# ANNUAL REPORT FOR 2009

**Michael's Branch Mitigation Site**  
**Alamance County**  
**TIP No. U-3110A**

Prepared By:  
Natural Environment Unit & Roadside Environmental Unit  
North Carolina Department of Transportation  
September 2009

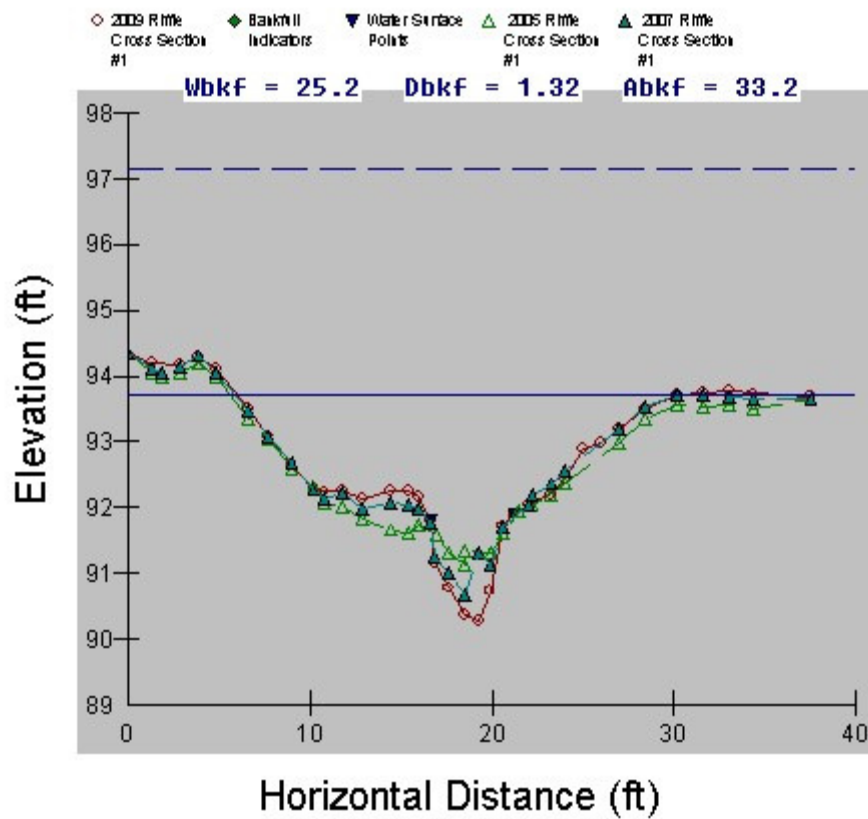
## Riffle Cross Section #1

Based on comparisons of Year 2005 to Year 2009 monitoring data, both cross sections have experienced some degradation within the channel. Graphs of the cross sections are presented in Appendix A. Future survey data will vary depending on actual location of rod placement and alignment; however, this information should remain similar in appearance.

Cross-Section #1 (Riffle) Abbreviated Morphological Summary			
	2005	2007	2009
Bankfull Cross Sectional Area (ft <sup>2</sup> )	29.7	28.2	33.23
Maximum Bankfull Depth (ft)	2.22	2.86	3.43
Width of the Floodprone Area (ft)	37.5	37.5	37.5
Bankfull Mean Depth (ft)	1.2	1.3	1.32
Width/Depth Ratio	18.14	17.04	19.1
Entrenchment Ratio	1.72	1.71	1.49
Bankfull Width (ft)	21.8	22	25.21

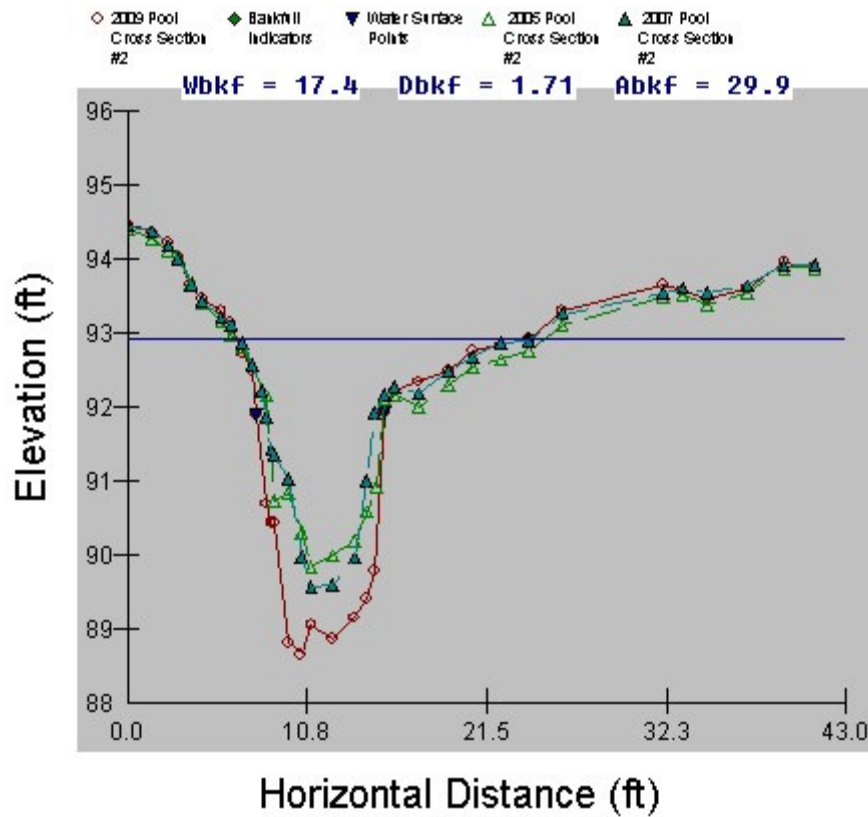
## Pool Cross Section #2

2005	2007	2009
<b>Bankfull Cross Sectional Area (ft<sup>2</sup>)</b>	26.69	27.61	29.86
<b>Maximum Bankfull Depth (ft)</b>	3.28	3.7	4.27
<b>Bankfull Mean Depth (ft)</b>	1.32	1.34	1.71
<b>Bankfull Width (ft)</b>	20.28	20.65	17.44

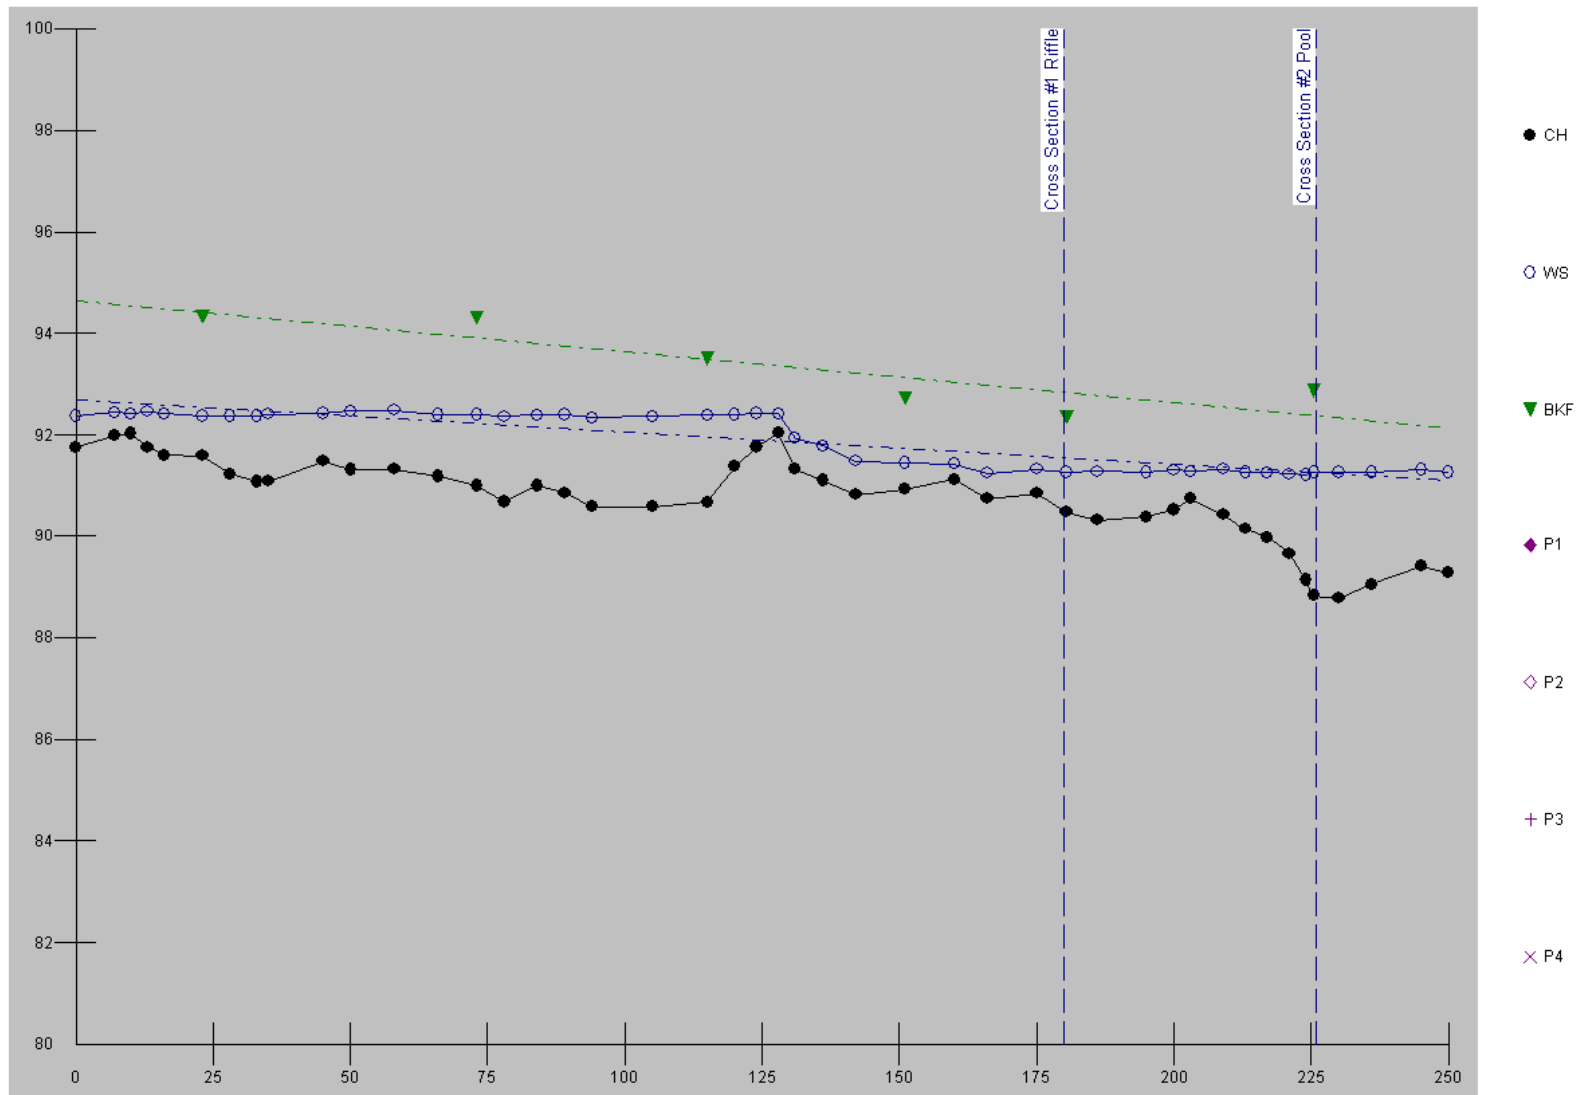
The longitudinal profile shows that the channel has experienced some degradation along the profiled reach but the streambanks remain stable with woody vegetation. A beaver dam that was located at Station 128+00 along the profiled reach was breached prior to completing the longitudinal profile survey. There were two other beaver dams located onsite downstream of the profiled channel that were also breached. NCDOT has contracted the N.C. Department of Agriculture to manage the site for beaver activity.
